Manhole Inspection Summary

Manhole # S21GG2024MH

Insp Date: **3/12/08 10:43 AM**

Location Address: **1111 BELLMORE RD**

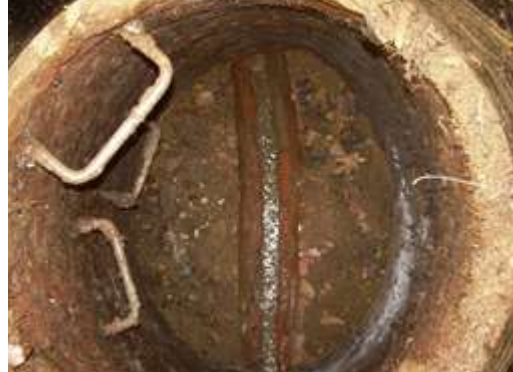
Top View

Bench ☒ Exists Material: **Brick** ☐ Parged ☒ **Debris** (not Condition related)

Surcharge ☒ **Evidence Of Surcharge** Depth: **1.5** (ft.) ☐ Active Surcharge Present

Evidence of surcharge - Bench debris.

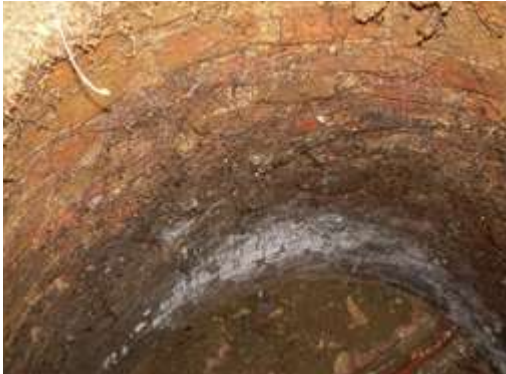
Defect

Condition: ☐ Sound ☐ Cracked ☒ **Root Intrusion** ☐ Loose Brick ☐ Deteriorated

Adjustment, Corbel and Barrel root intrusion and infiltration - other side.

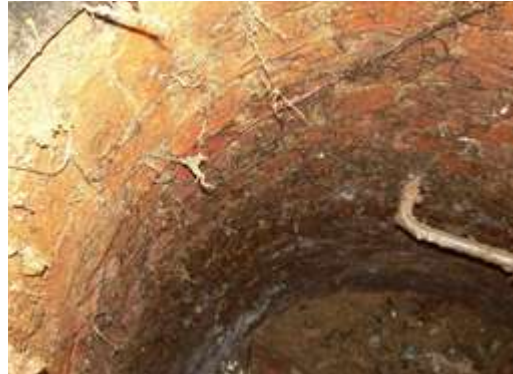
Defect

Adjustment, Corbel and Barrel root intrusion and infiltration.

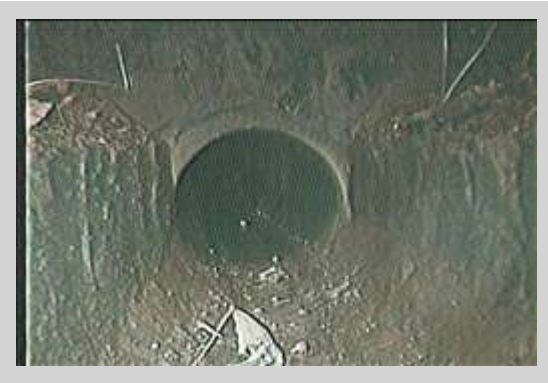
8 in. Circular Gravity Sewer Pipe Out @ 12 O'Clock

Condition: ☐ Sound ☐ Cracked ☐ Root Intrusion ☒ **Deteriorated** ☐ Leaks ☐ Debris

Channel deterioration.
